Debris/Ice/TPS Assessment and Integrated Photographic Analysis of Shuttle Mission STS-82

Technical Memorandum 112647

April 1997

**DEBRIS/ICE/TPS ASSESSMENT
AND
INTEGRATED PHOTOGRAPHIC ANALYSIS
OF
SHUTTLE MISSION STS-82**

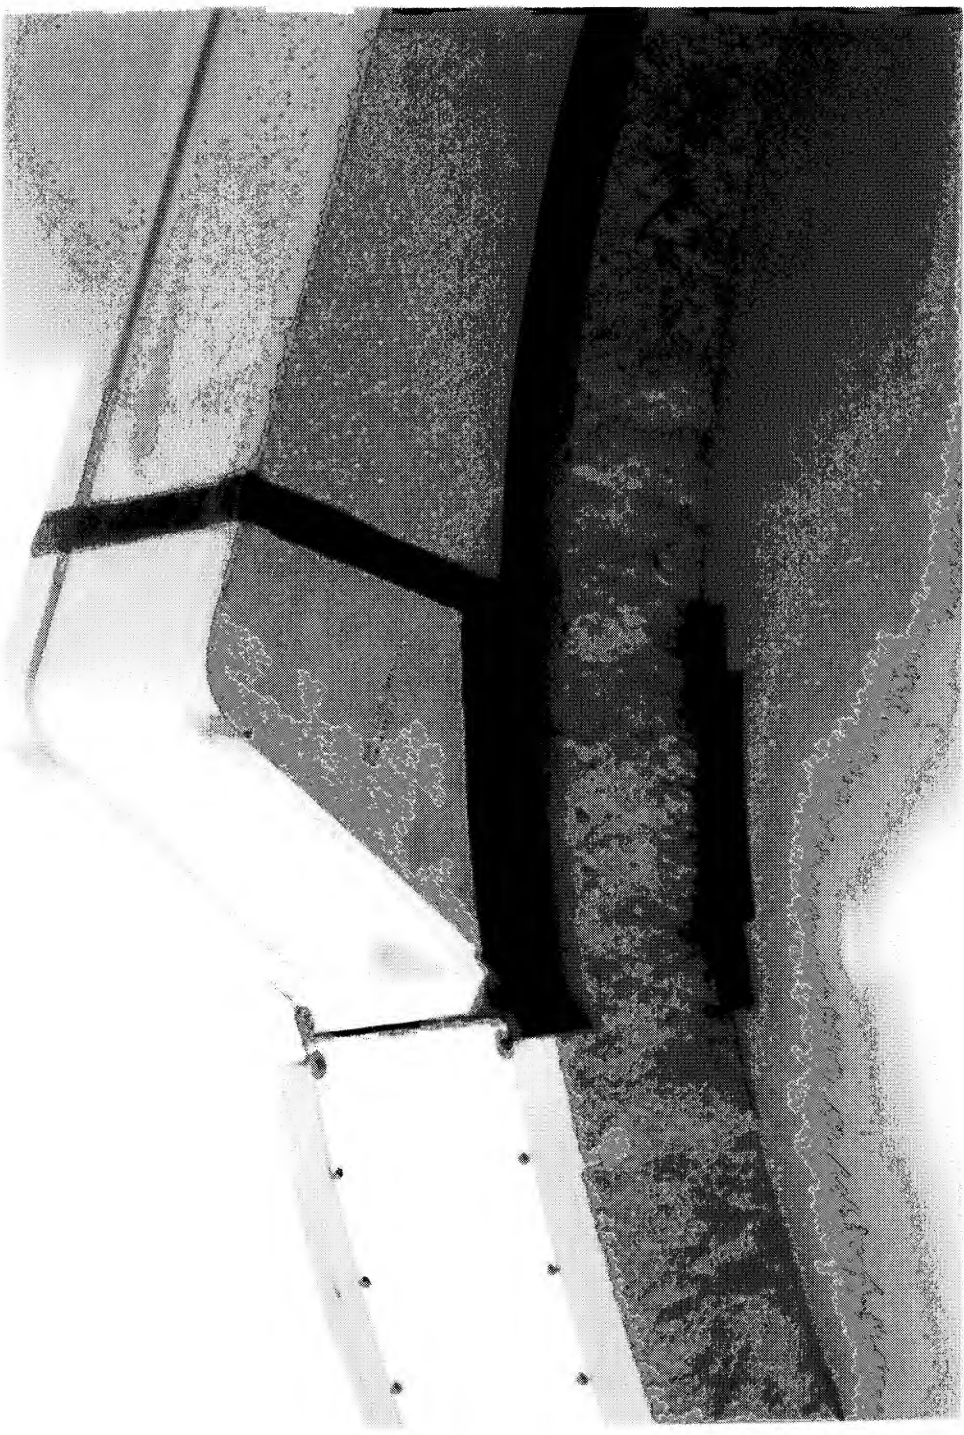
Photo 2: Tape Inadvertently Left on LH SRB Aft Booster

Tape was inadvertently left on the LH SRB aft booster just aft of the IEA. The tape, used during IEA closeout/ablator trimming, was detected during the Pre-Launch Inspection, but after the Orbiter Weather Protection (OWP) platforms had been retracted. MRB approval (IPR 82V-0262) to fly the tape rather than re-extending the OWP's was obtained.

Tape inadvertently left on the LH SRB aft booster just aft of the IEA adhered to the SRM case through tower clear (E-31 and E-40). The tape, used during IEA closeout/ablator trimming, had been detected during the Pre-Flight Inspection, but after the Orbiter Weather Protection (OWP) platforms had been retracted. MRB approval (IPR 82V-0262) to fly the tape rather than re-extending the OWP's was obtained.

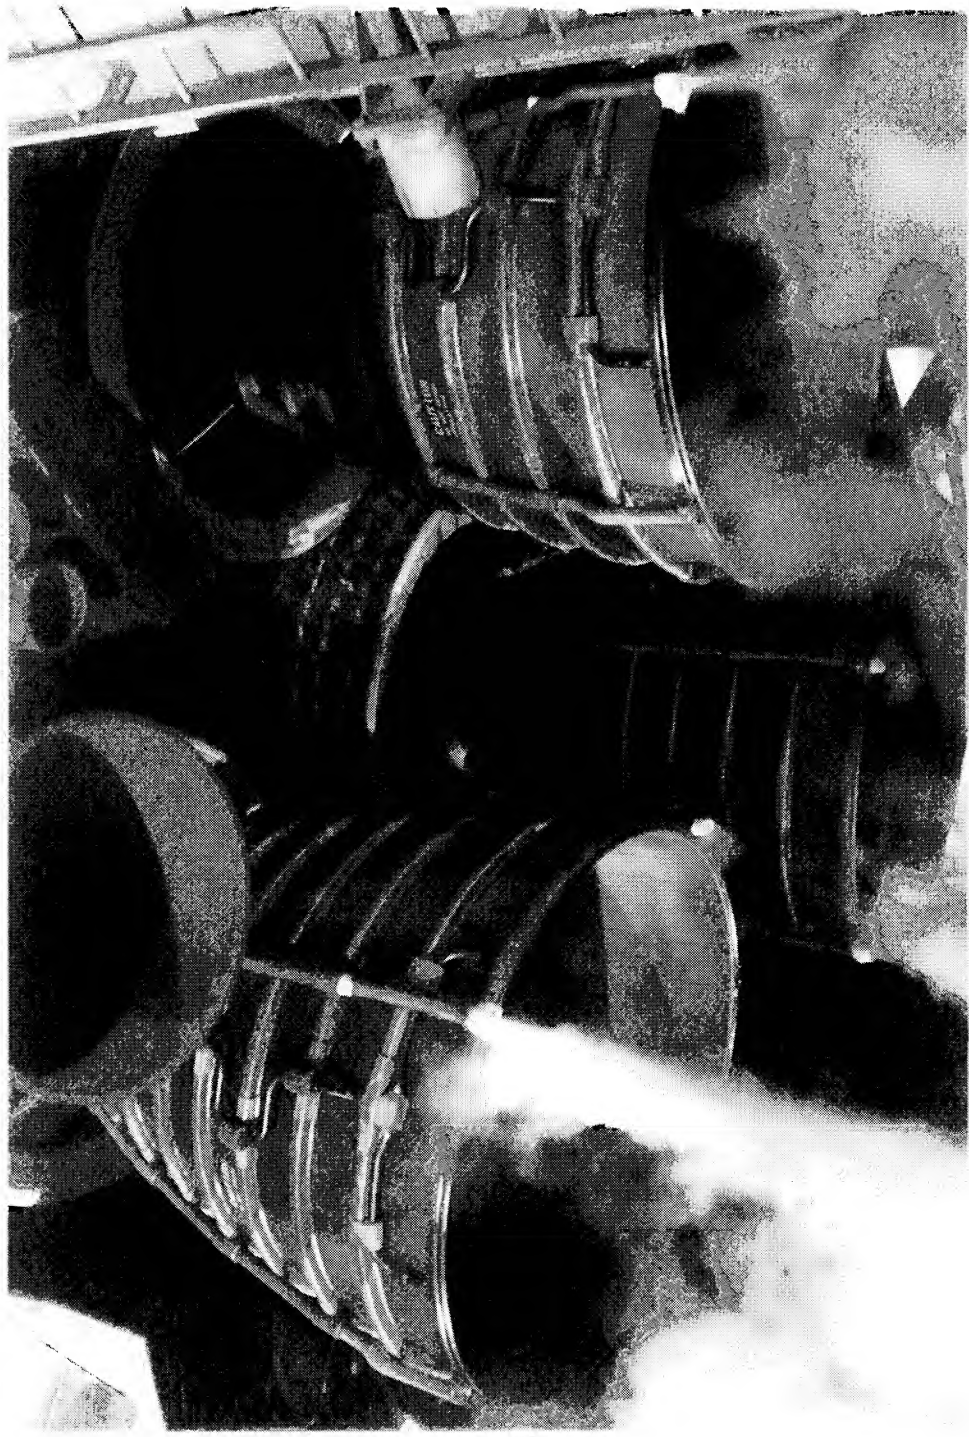
Photo 4: Ice/Frost and Condensate on SSME #2 Heat Shield-to-Nozzle Interface

No Orbiter tile or RCC panel anomalies were observed. The F2U, R2U, R3D, and R4D RCS thruster covers were intact, but tinted green indicating small internal vapor leaks. Ice/frost and condensate had formed on SSME #1 and #2 heat shield-to-nozzle interfaces. Condensate was present on the SSME #3 heat shield-to-nozzle interface. An infrared scan revealed no unusual temperature gradients on the base heat shield or engine mounted heat shields.

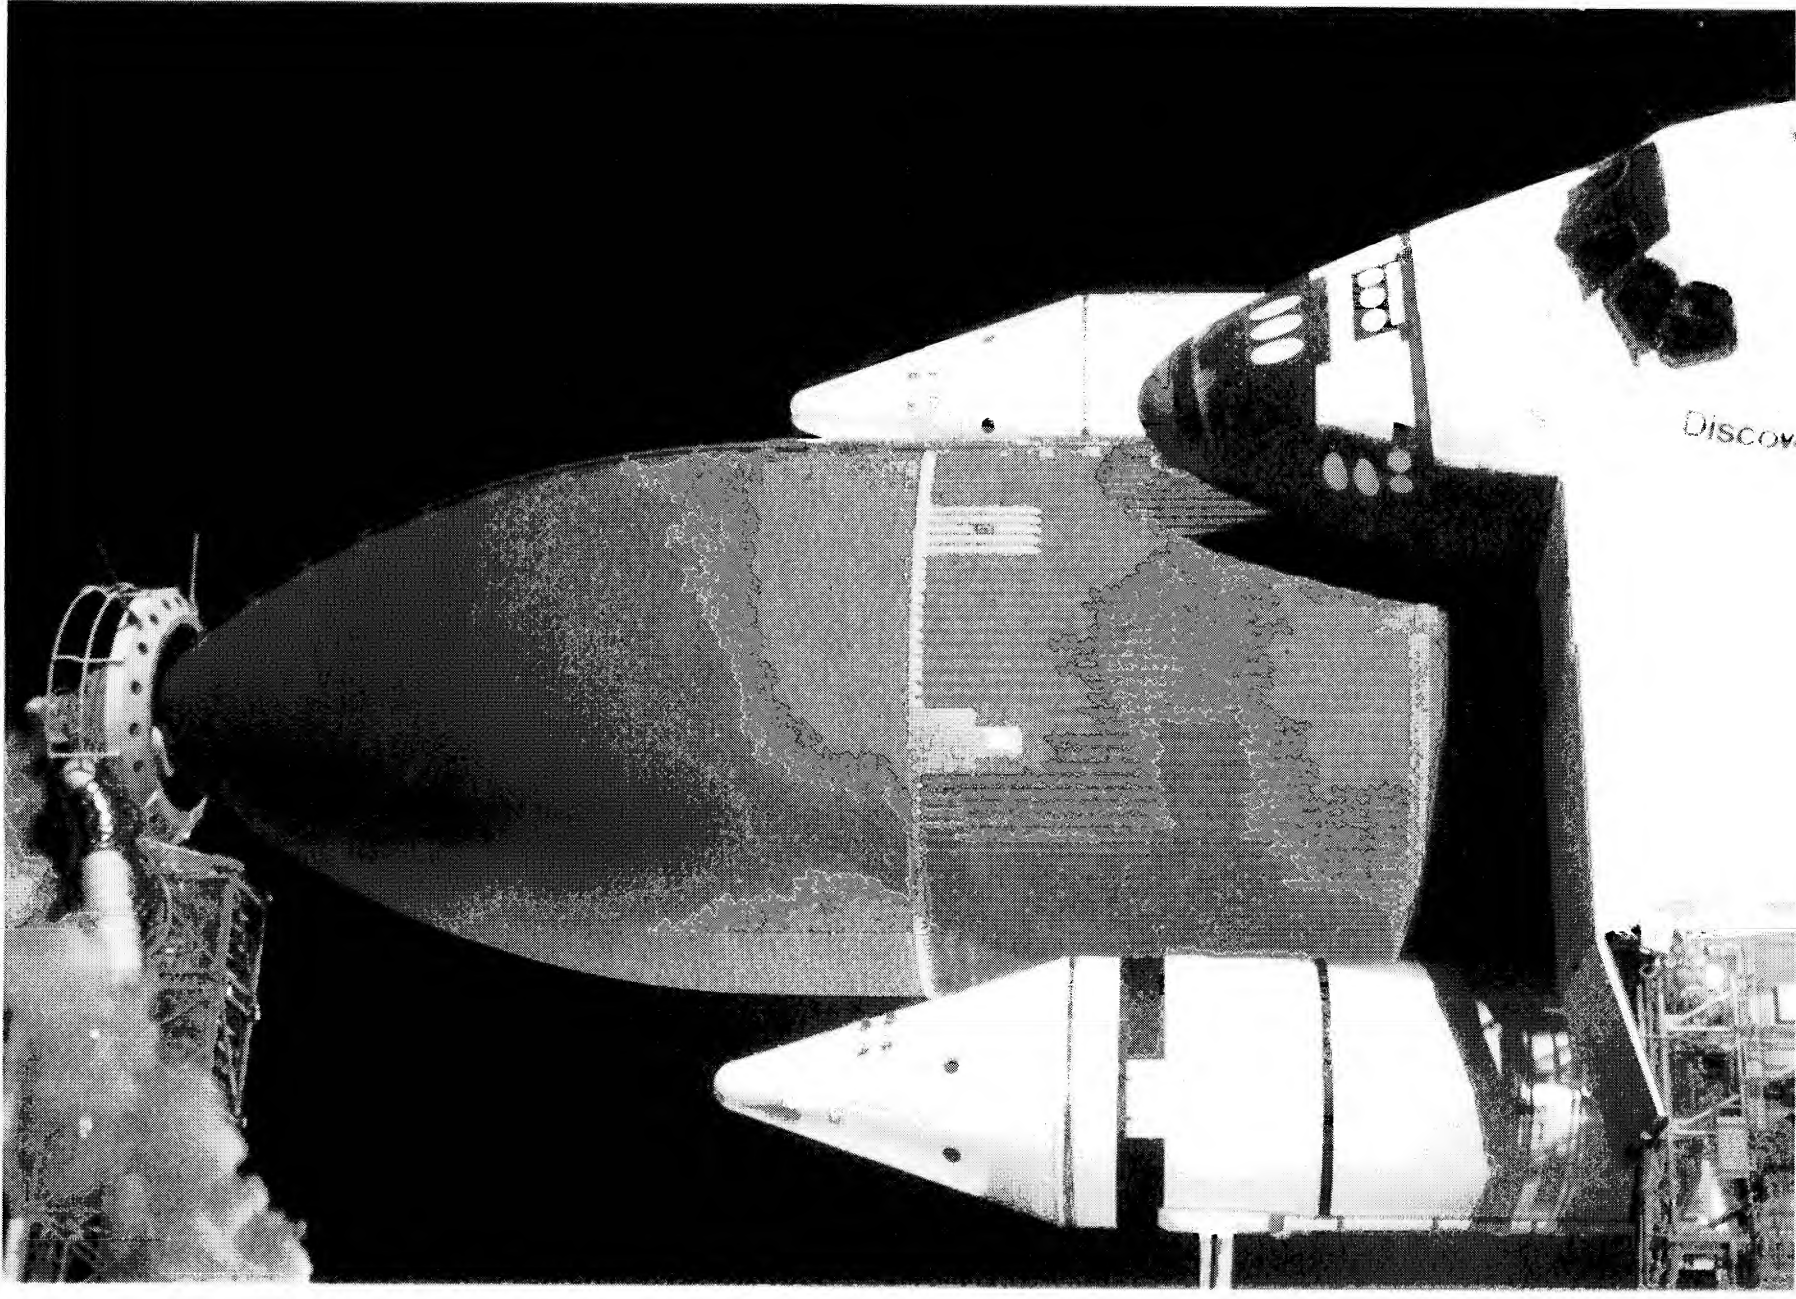
Photo 5: LO2 Tank and Intertank

The Intertank acreage exhibited no TPS anomalies. Ice/frost accumulation on the GUCP appeared typical. The average surface temperature of the Intertank TPS was 53 degrees F.

The Final Inspection Team observed very light condensate, but no ice or frost accumulations, on the LO2 tank. TPS surface temperatures ranged from 42-48 degrees F.

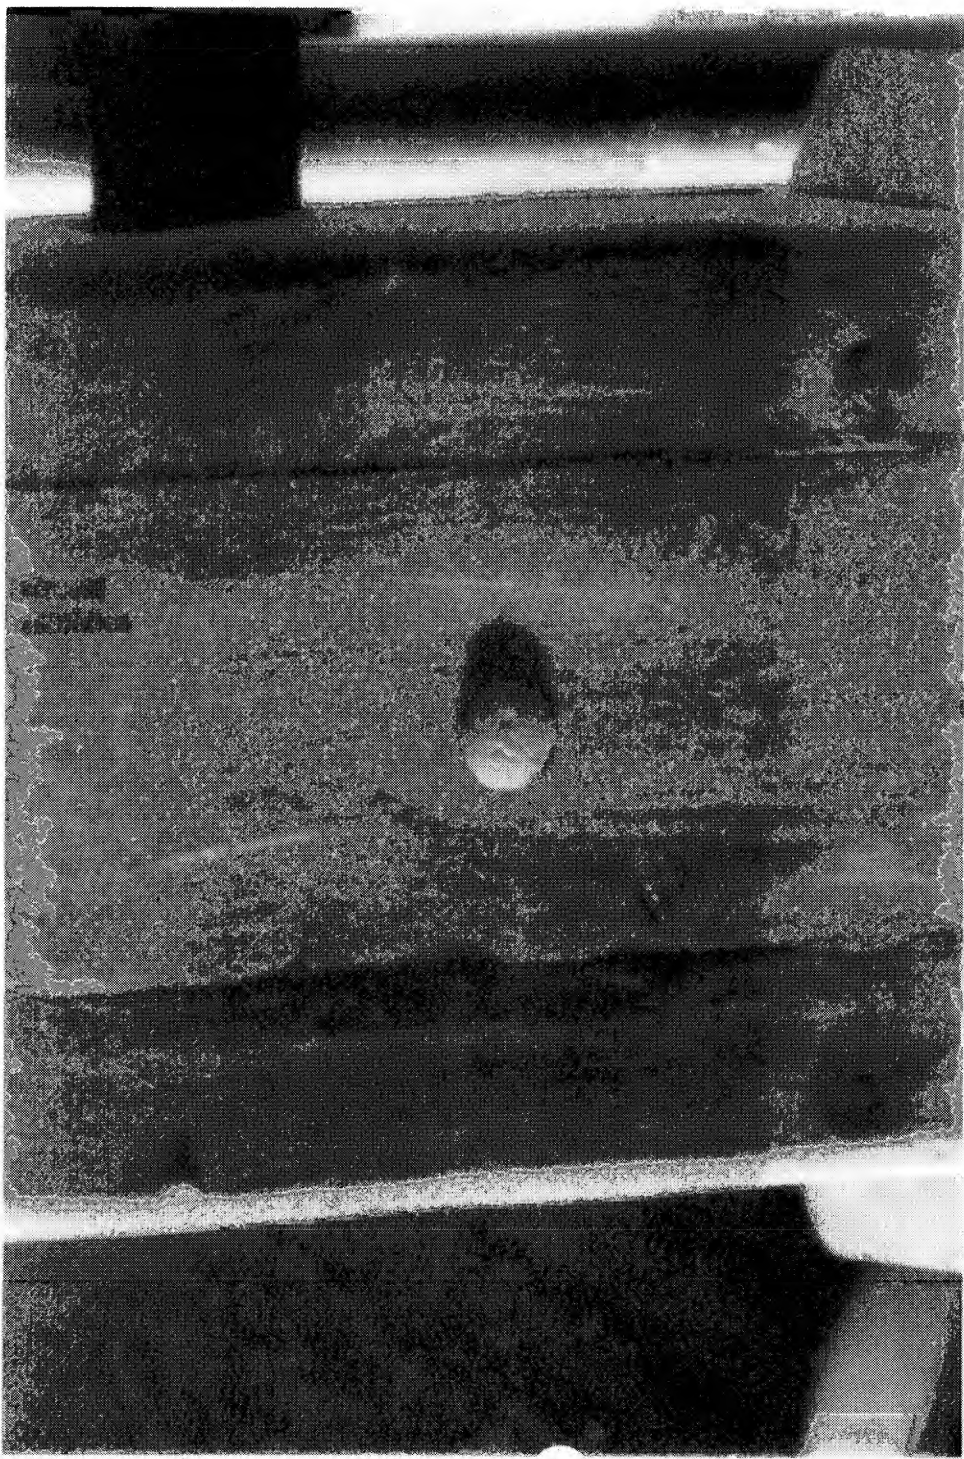
Photo 6: Protruding PDL Repair

A 1-1/2 inch diameter PDL repair on the aft surface of the umbilical cable tray was not flush (protruded slightly) with the surrounding TPS.

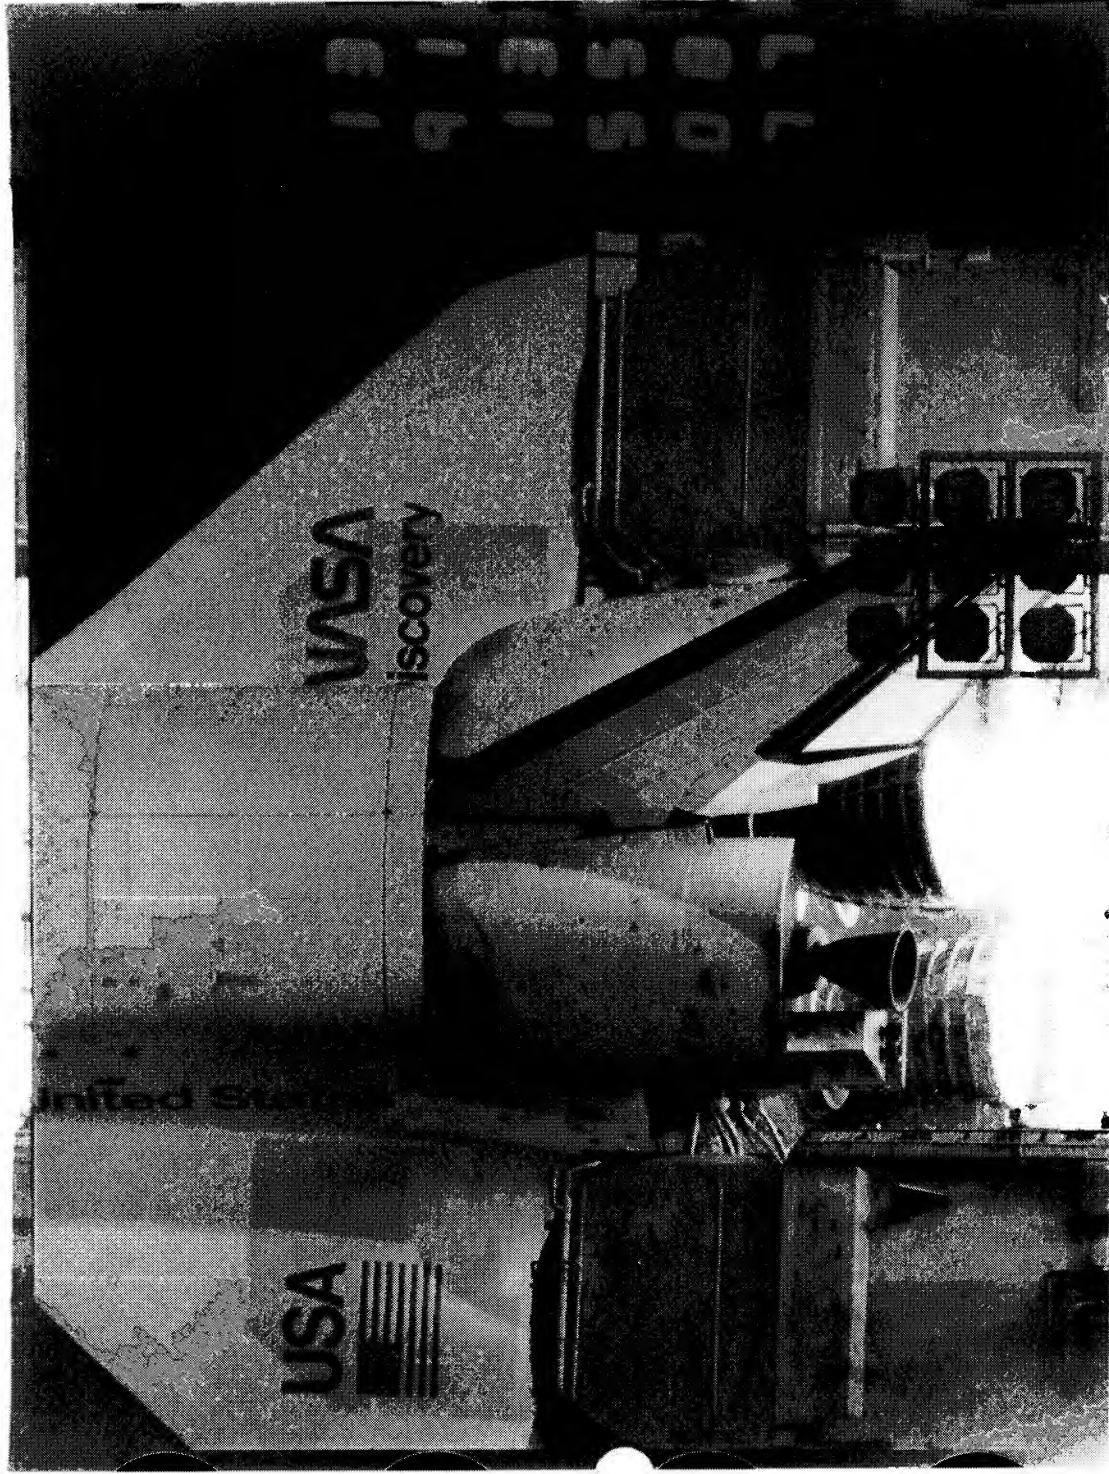
With the exception of Mach diamond formation (in the order 2-3-1), SSME ignition appeared normal (OTV-051, -070, -071). Free burning hydrogen drifted up to the OMS pods (OTV-070 and -071; E-16, -19).

Photo 7: SSME Mach Diamond Formation
SSME #2 Mach Diamond formed prior to SSME #3.

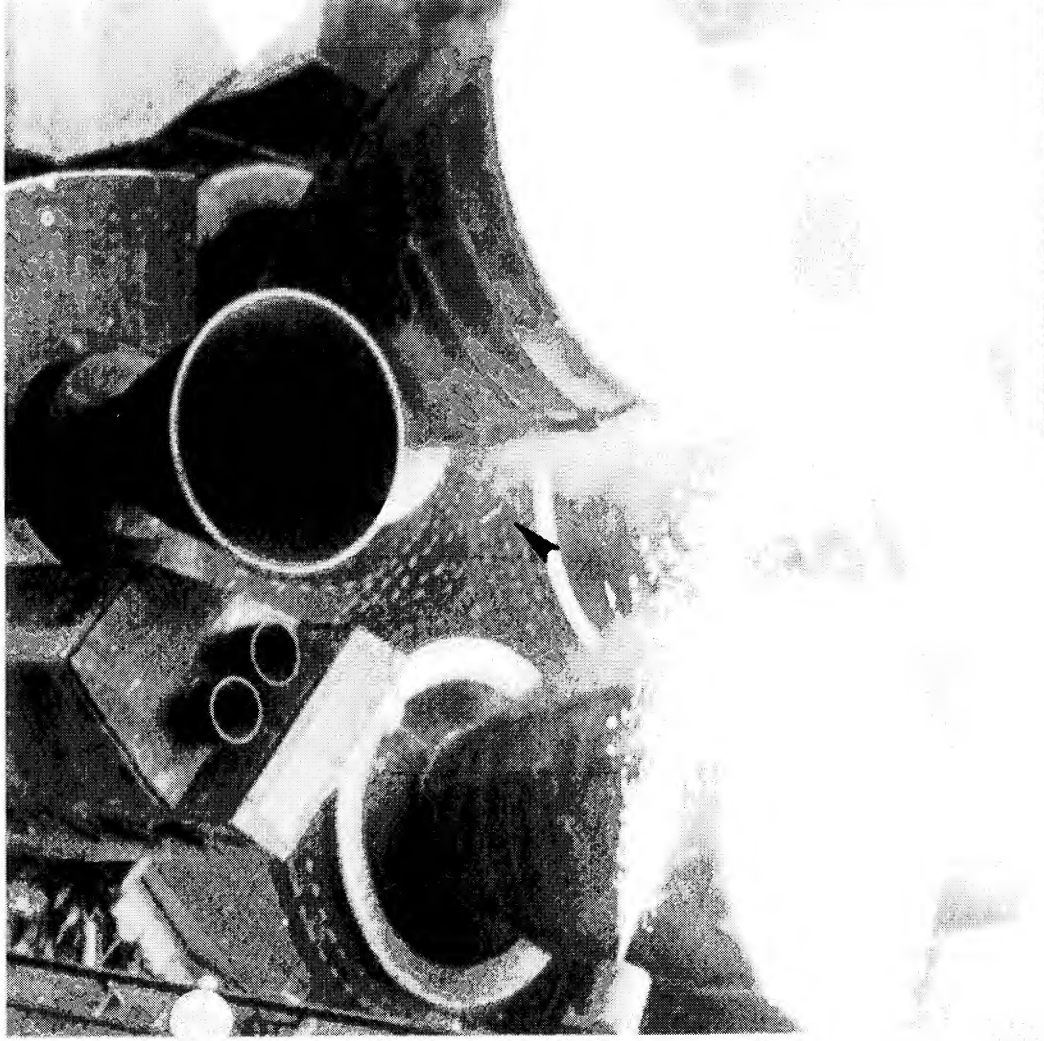
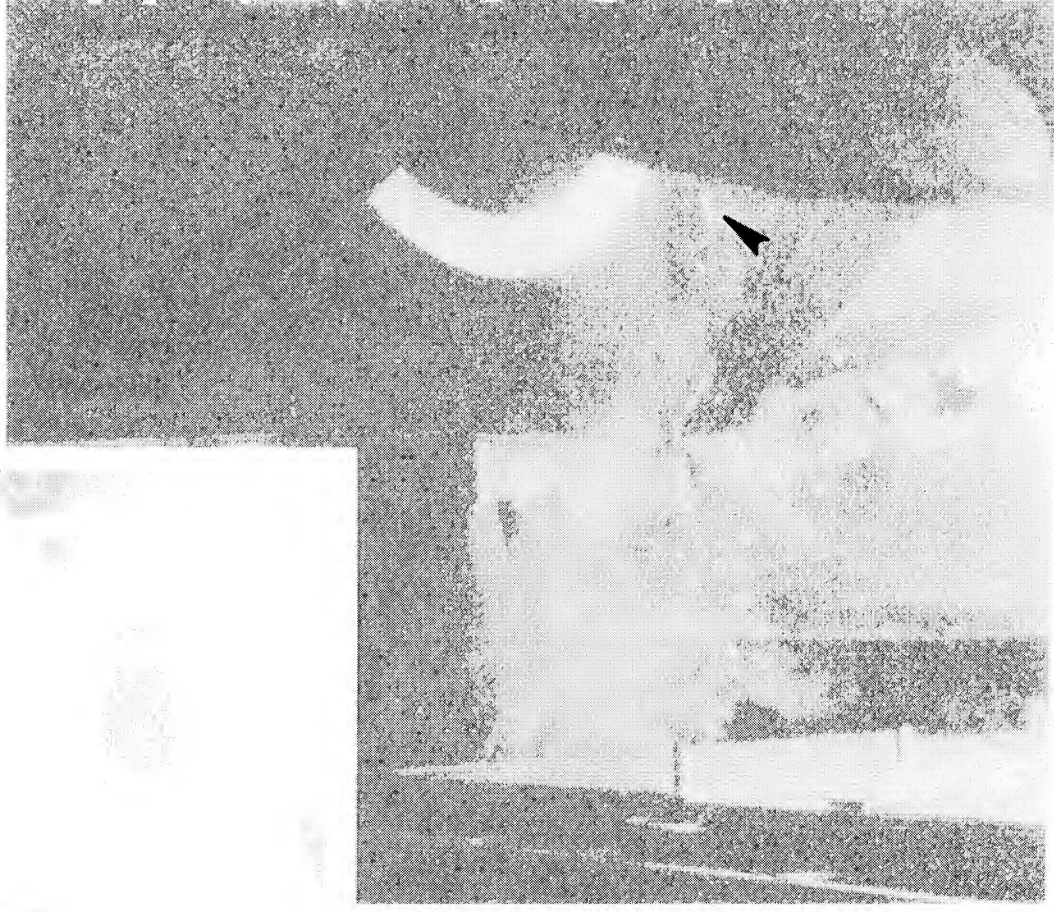
Photo 8: GSE Tile Shim

An orange-colored GSE tile shim/spacer falling outboard of SSME #3 appeared to originate from the base heat shield. Another orange-colored tile shim/spacer first appeared behind the LH OMS nozzle heat shield and fell aft past SSME #1 without contacting flight hardware.

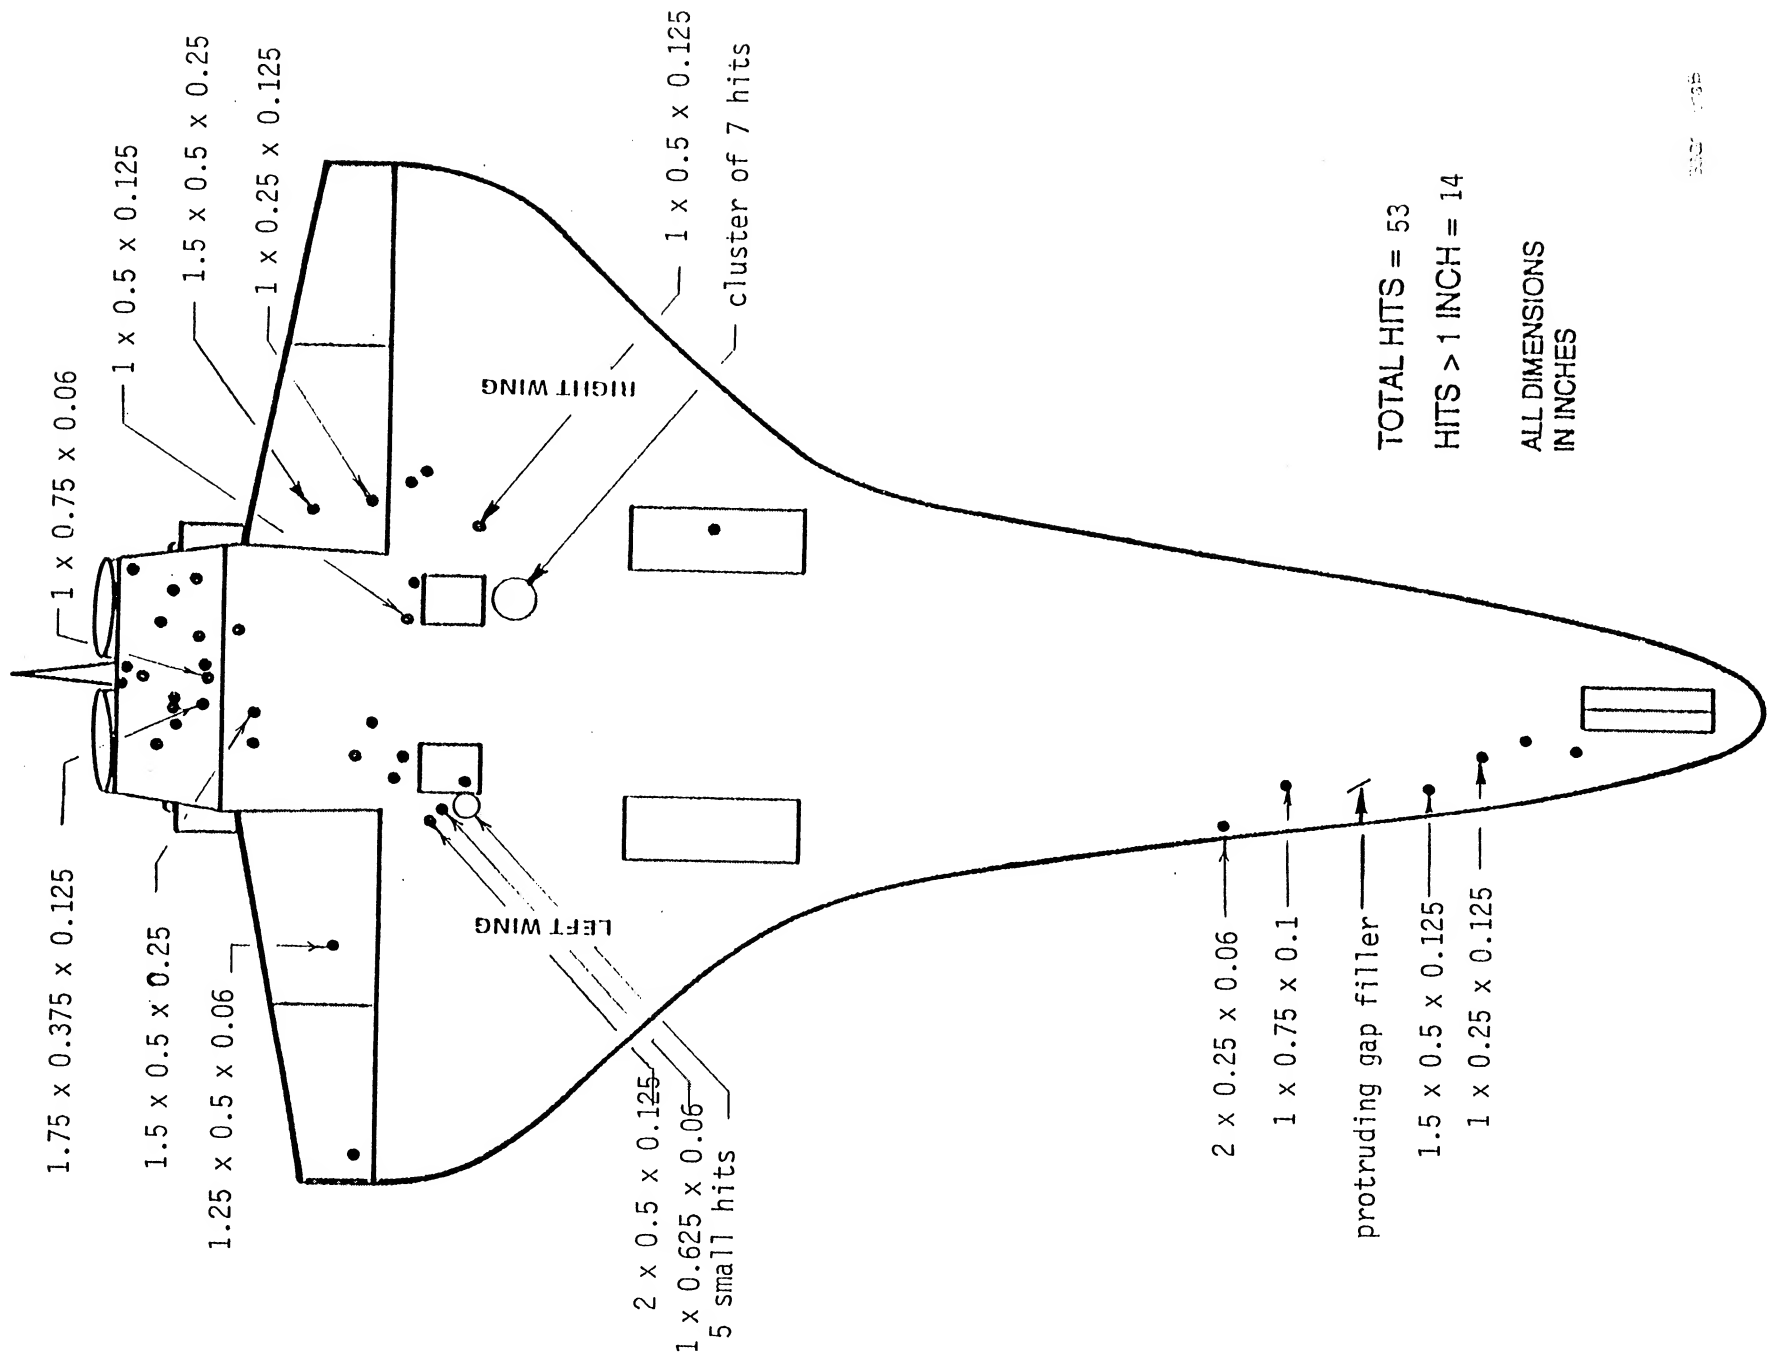
Figure 1: Orbiter Lower Surface Debris Damage Map

The Orbiter lower surface tiles sustained 53 damage sites, of which 14 were larger than 1-inch long in size. The largest lower surface tile damage site was located on the left chine about midway between the nose gear door and the left main gear door. The site measured 2-inches long by 1/4-inch wide by 1/16-inch maximum depth.

Tile damage sites aft of the LH2 and LO2 ET/ORB umbilicals were typical. The damage was most likely caused by impacts from umbilical ice or shredded pieces of umbilical purge barrier material flapping in the air stream, both of which were observed in launch films.

TOTAL HITS = 53
HITS > 1 INCH = 14
ALL DIMENSIONS
IN INCHES

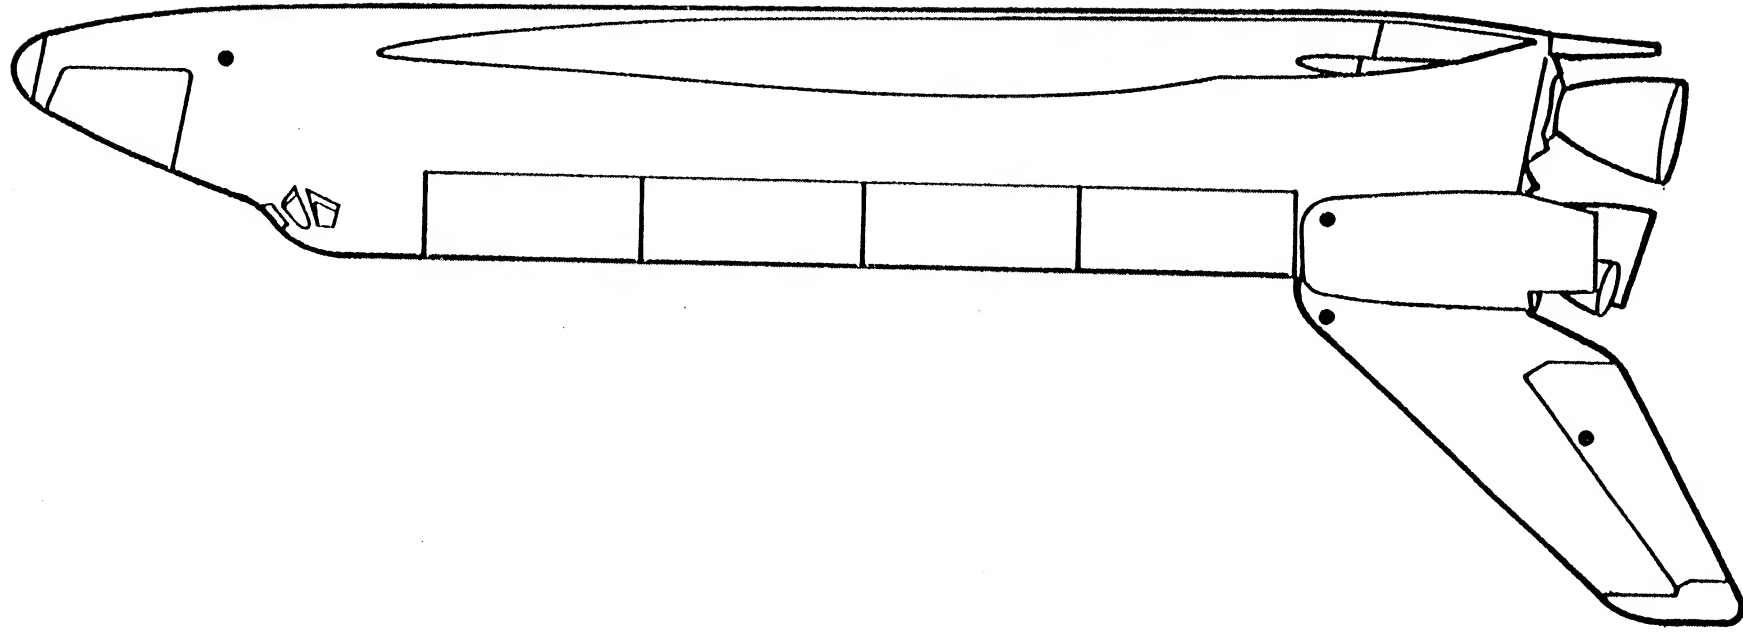
Figure 2: Orbiter Right Side Debris Damage Map

TOTAL HITS = 4
HITS > 1 INCH = 0

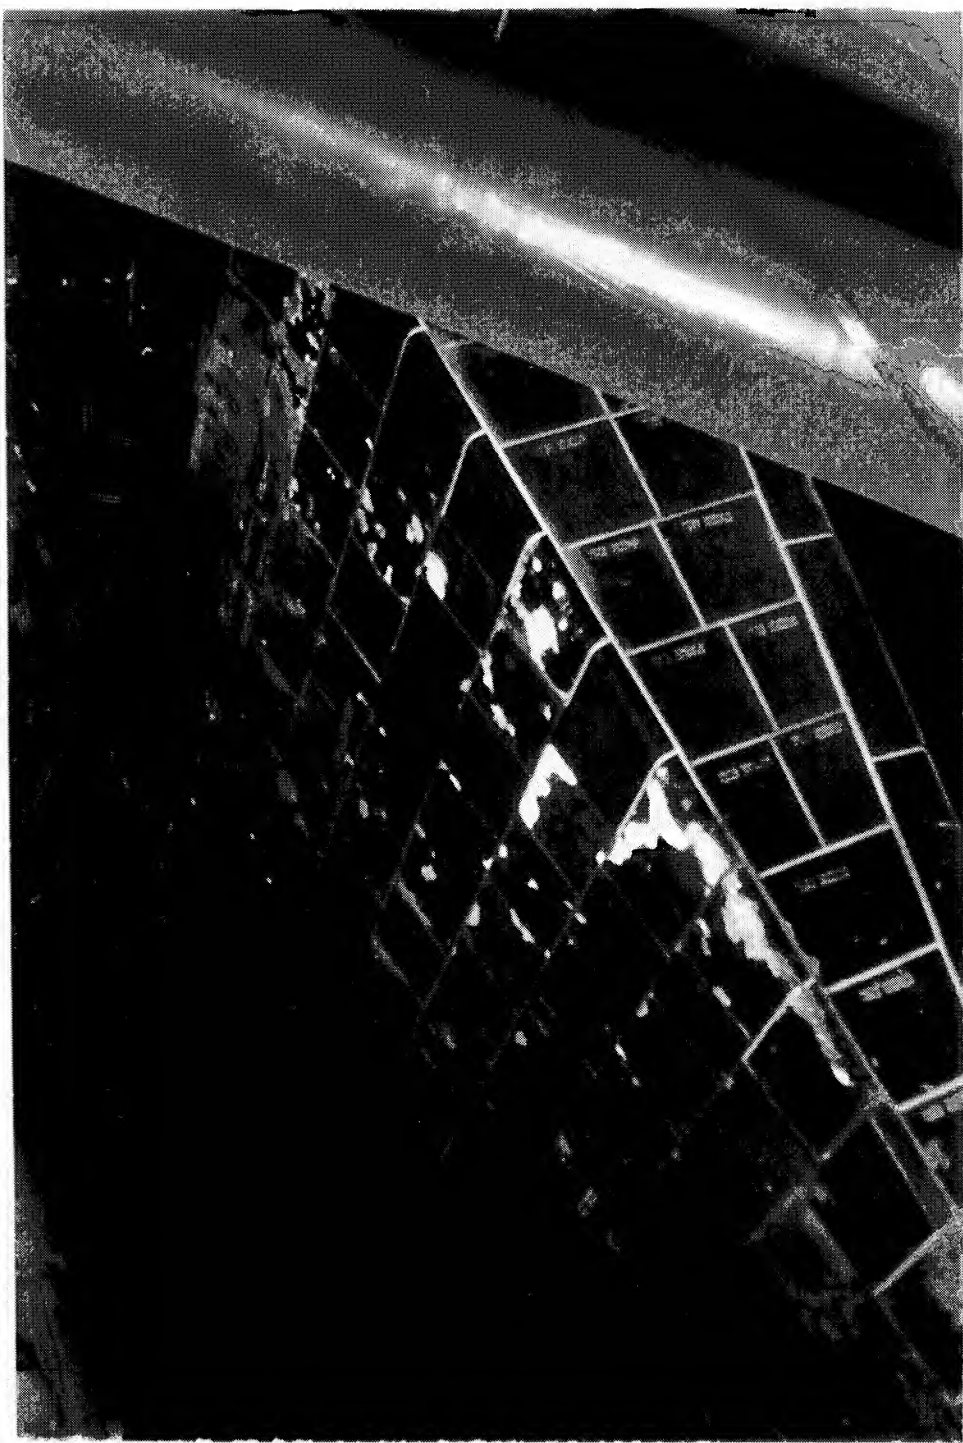
Photo 19: Body Flap Upper Surface Tile Damage

Tiles on the upper surface of the body flap near the outboard edges sustained greater than usual damage from downward firing RCS thrusters.

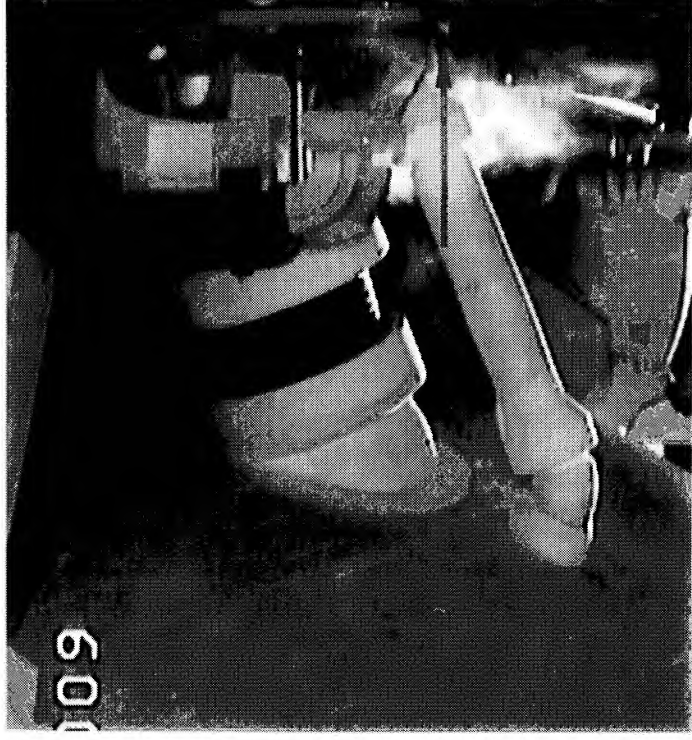
Figure 2.1 (A) Ice Debris Strike to Umbilical Well Door Sill

Multiple pieces of ice debris were seen falling from the LH2 ET/Orbiter umbilical during SSME ignition. Ice debris was seen to strike the LH2 umbilical well door sill (08:55:11.86 UTC) and the LH2 four inch recirculation line (08:55:15.20 UTC). No damage was noted (Camera OTV009).

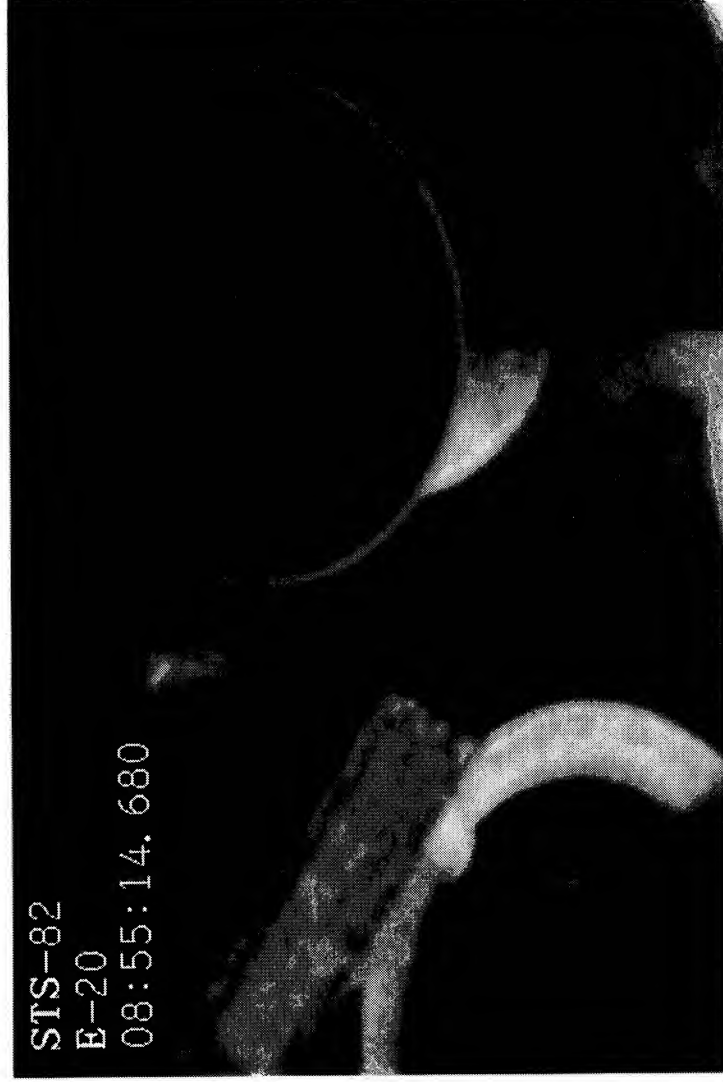
Figure 2.1 (B) Possible Tile Shim Debris Near Left RCS Stinger

A single, red-colored, rectangular-shaped piece of debris (possibly a tile shim) was seen coming from behind the left RCS stinger and fell aft between SSME #1 and SSME #2 during SSME ignition (08:55:14.680 UTC). No follow-up action was requested (Camera E20).

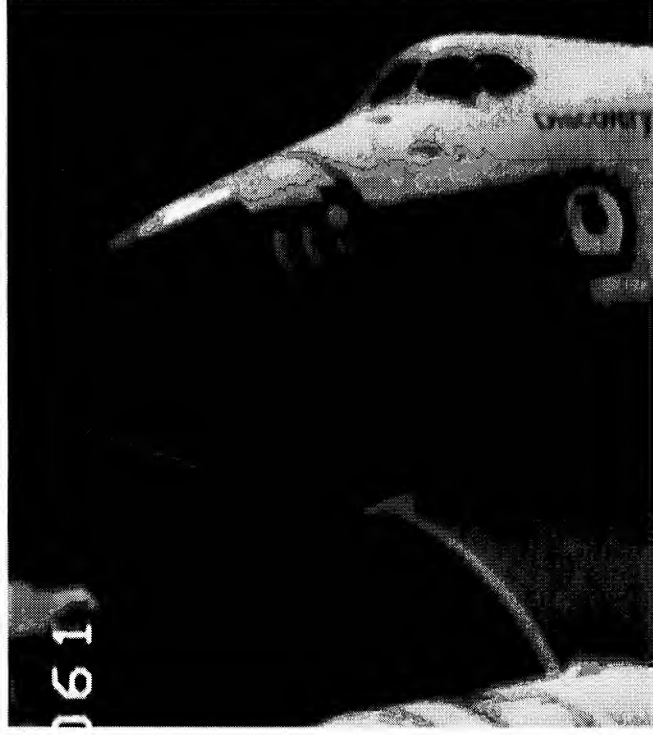
Figure 2.1 (C) White Debris Near ET Upper Feedline Bellows

Four pieces of ice were shaken loose from the LO2 feedline upper bellows during vehicle "twang", fell aft between the Orbiter and the ET, and eventually passed the right inboard elevon. A fifth piece of ice from the same bellows was shaken loose at liftoff (OTV 061 and OTV 054). No contact with the lower surface tiles was observed.

Four pieces of white debris, first seen near the ET upper feedline bellows, fell aft between the Orbiter and the ET just prior to liftoff (08:55:14.0 UTC). A fifth

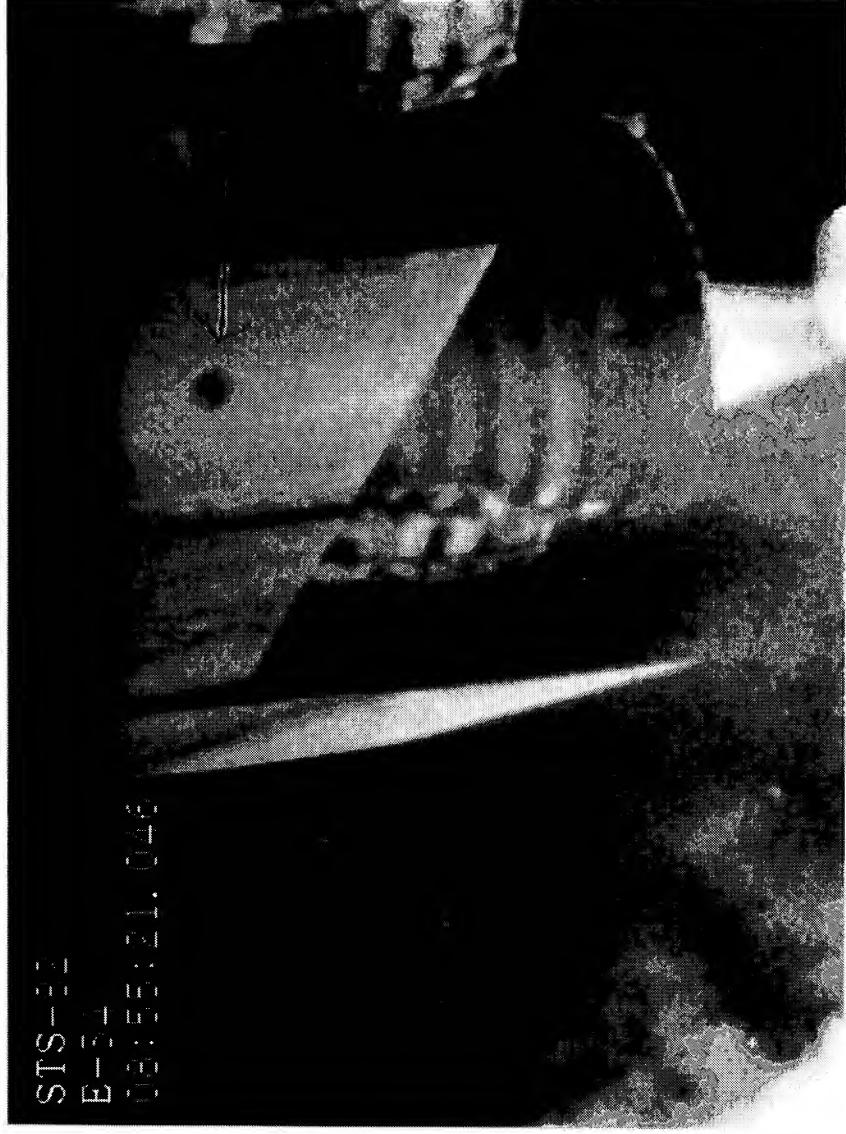
Figure 2.1 (D) Unidentified Piece of Debris Near Left Elevon

A dark unidentified piece of debris (possibly a bird) was seen falling aft near the left elevon during liftoff (08:55:21.046 UTC) (Camera E34).

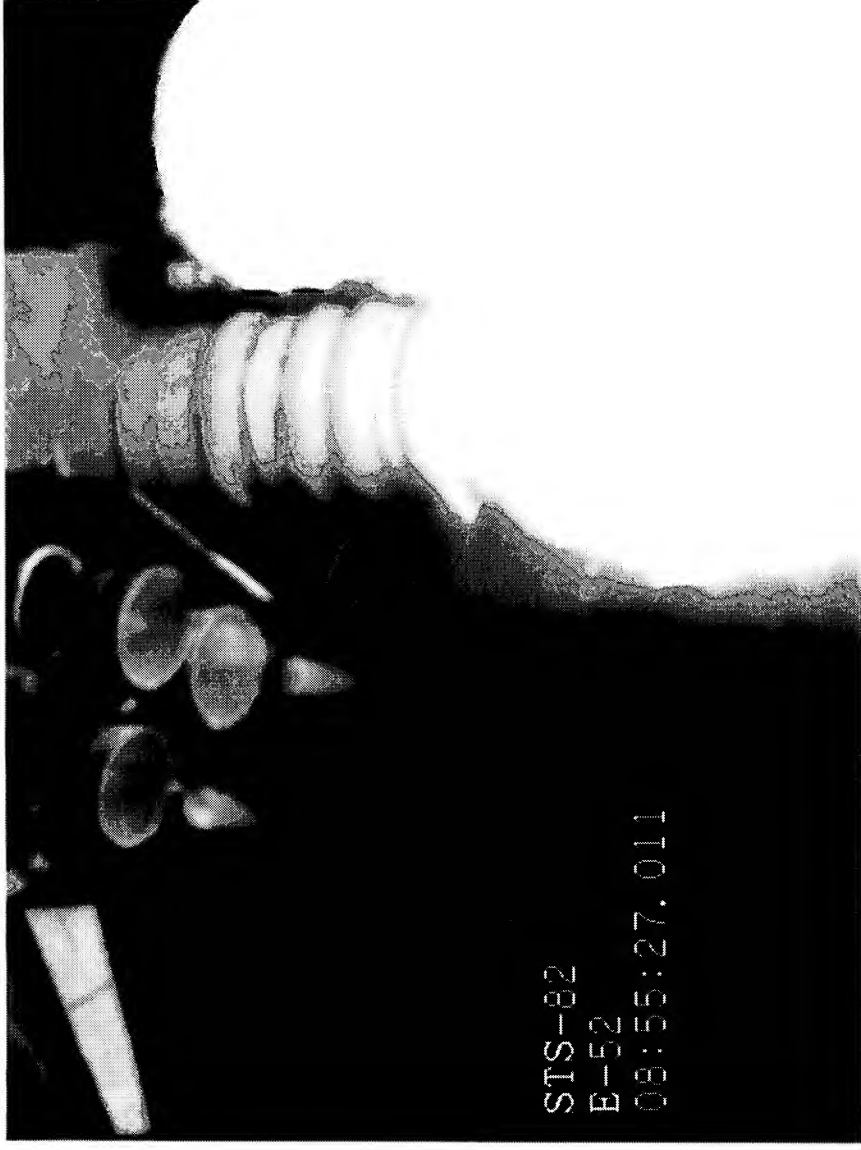
Figure 2.2 (A) Debris at Beginning of Roll Maneuver.

Most of the ET/ORB umbilical purge barrier material came loose and fell aft at the beginning of the roll maneuver. The purge barrier was visible at 08:55:26.990 UTC with a four foot long piece of tape at 08:55:27.659 UTC (E-52, -59).

Debris (probably ET/Orbiter purge barrier material) fell aft of the launch vehicle at the beginning of the roll maneuver (08:55:27.0 UTC). A long piece of tape-like material (probably from the ET/Orbiter umbilical area) was also seen falling aft along the body flap (08:55:27.6 UTC) (Cameras E52, E54, E212, E222, E223).

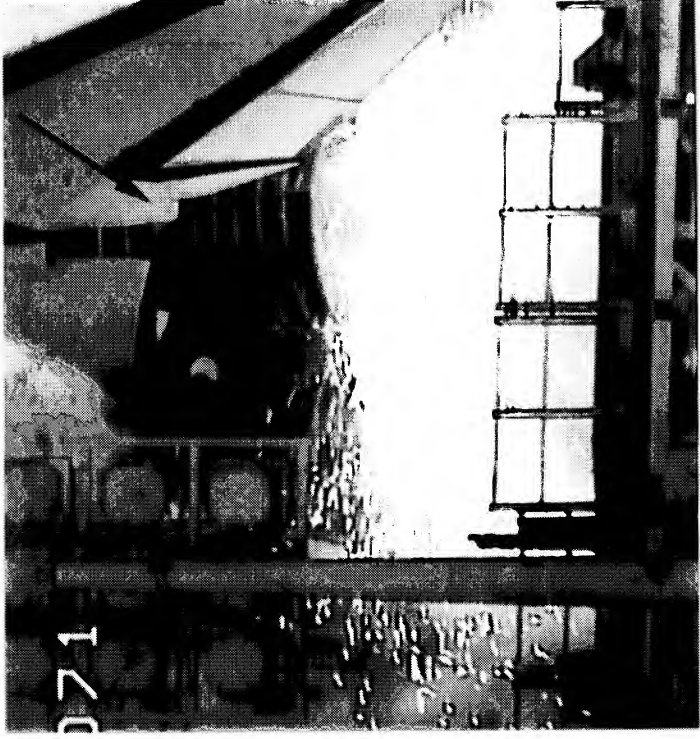
Figure 2.3 Orange Vapor during SSME Ignition

Orange vapor, probably free burning hydrogen, was seen above the SSME rims, near the body flap, and near the base of the vertical stabilizer during SSME ignition (08:55:14 UTC). Orange vapors have been seen on previous missions (Cameras OTV071, E4, E19).

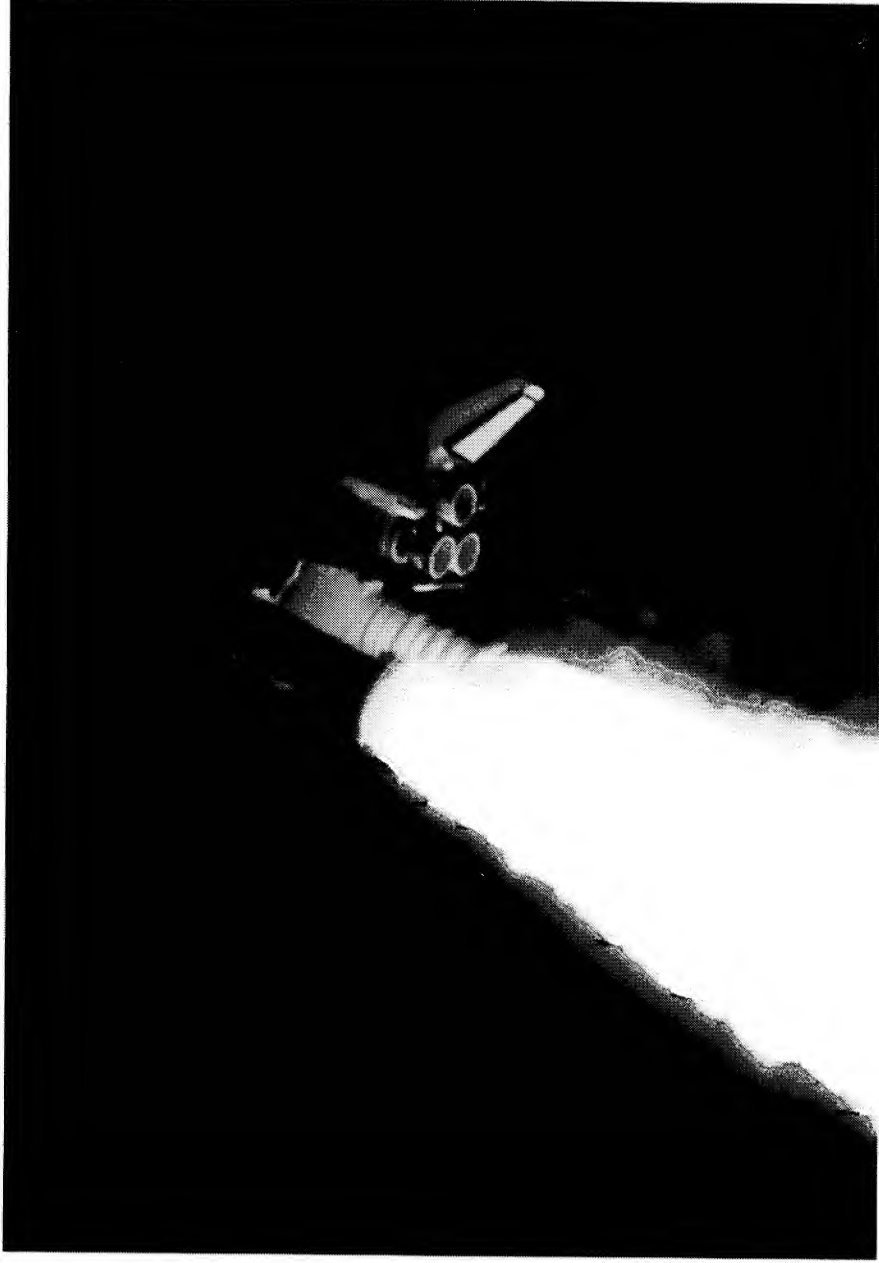
Figure 2.4 (A) Flare in SSME Exhaust Plume

Seven orange-colored flares (probably RCS paper debris induced) were seen in the SSME exhaust plume during ascent (Cameras E220, E212, E222, E223). The orange-colored flares were seen over a five second time period beginning at 08:55:50.695 UTC (33.671 seconds MET). Flares in the SSME exhaust plumes have been seen on previous missions. However, the rapid succession of the STS-82 flares and the resultant color changes seen in the SSME exhaust plumes were more obvious than typically seen on previous missions. Camera film (E220) of the flares was reviewed with an engineer from the JSC Structures and Mechanics Division/ES3. The ES3 engineer concluded that the flares were not caused by falling tiles. No follow-up action was requested. A description of the flare events is shown in Table 2.4.
